Office of Structural Materials

Quality Assurance and Source Inspection

Contract #: 04-0120F4Cty: SF/ALA Rte: 80 PM: 13.2/13.9File #: 1x.28**WELDING INSPECTION REPORT****Resident Engineer:**Pursell, Gary**Address:** 333 Burma Road**City:** Oakland, CA 94607**Report No:** WIR-012803**Date Inspected:** 25-Mar-2010**Project Name:** SAS Superstructure**OSM Arrival Time:** 630**Prime Contractor:** American Bridge/Fluor Enterprises, a JV**OSM Departure Time:** 1500**Contractor:** American Bridge/Fluor Enterprises, a JV**Location:** Job Site**CWI Name:** Bernie Docena**CWI Present:** Yes No**Inspected CWI report:** Yes No N/A**Rod Oven in Use:** Yes No N/A**Electrode to specification:** Yes No N/A**Weld Procedures Followed:** Yes No N/A**Qualified Welders:** Yes No N/A**Verified Joint Fit-up:** Yes No N/A**Approved Drawings:** Yes No N/A**Approved WPS:** Yes No N/A**Delayed / Cancelled:** Yes No N/A**Bridge No:** 34-0006**Component:** Orthotropic Box Girder**Summary of Items Observed:**

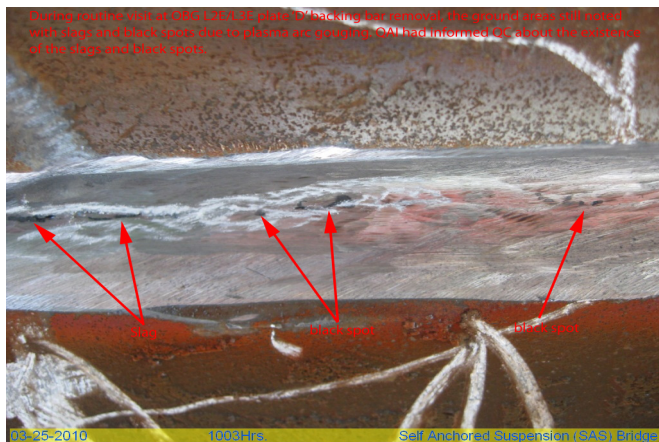
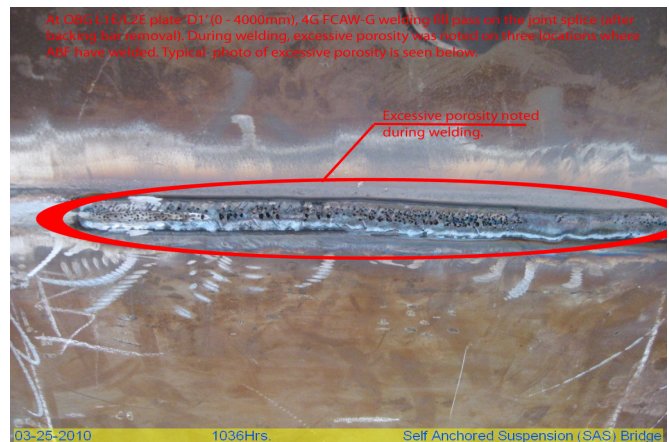
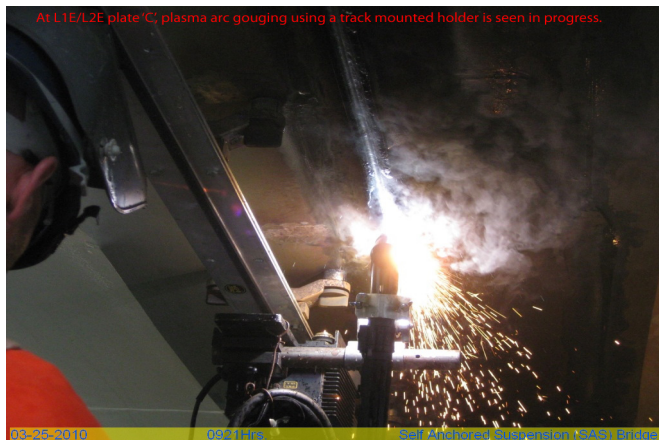
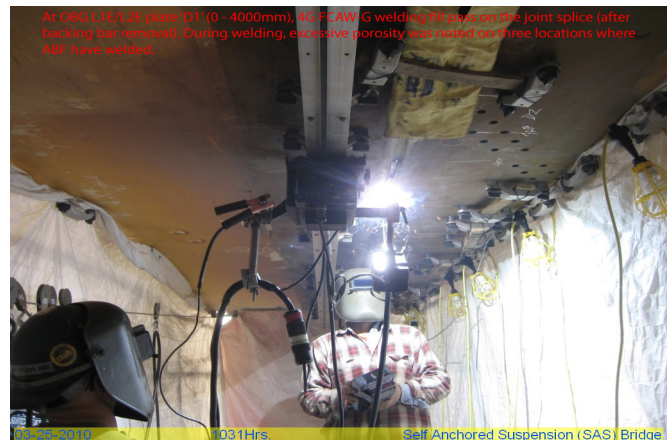
During welding on the fill pass of the back welding of the joint splice on location mentioned above, the 10 inches long welded were noted of excessive porosity. Due to the porosity that existed throughout the whole length welded, the welder started another weld at different location (2nd) within joint splice plate D1. Again, the welder welded around 16 inches long and noted same result of excessive porosity throughout the whole length of the weld. After

having two locations of excessive porosity, the two welders stopped welding and started grinding the porosity. To have better access to grind the porosity, ABF personnel temporarily removed the heater blankets. In doing this, the preheat temperature of more than 200 degree Fahrenheit during welding went down to just 85 degree Fahrenheit after grinding.

ABF personnel put back the heater blanket and after attaining a preheat temperature of more than 200 degree Fahrenheit, the welder started welding another location (3rd) within the joint splice plate D1. Again, the welder welded around 12 inches long and noted same result of excessive porosity throughout the whole length of the weld. QA observed that all three locations that the welder welded have excessive porosity throughout the length of the welds.

QAI also randomly observed ABF personnel perform back gouging of backing bar at OBG L1E/L2E plate 'C' using a track mounted Esab plasma arc machine. Per ABF personnel, gouging of the backing bar will take multiple passes before the backing bar would be totally removed. In another OBG location, OBG L2E/L3E plate 'D', grinding of the gouged backing bar removal still in progress. Measured depth of the gouged and ground groove of the splice joint was 6.0mm.
